Carrington Way Apartments

Location: Newark, DE • Size: 15 Buildings comprised of 165 units •
Owner: The Capital Realty Group

PROJECT BACKGROUND

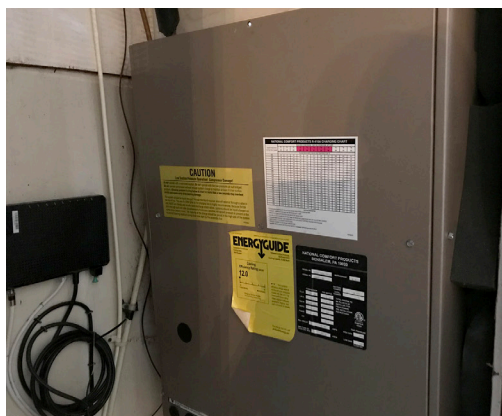
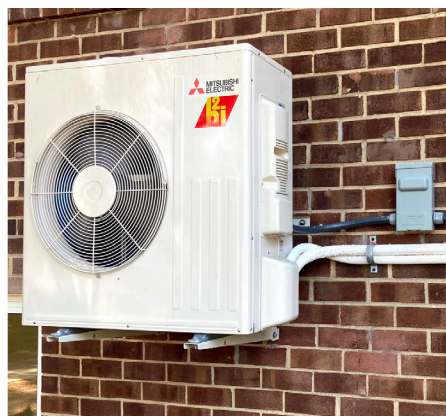
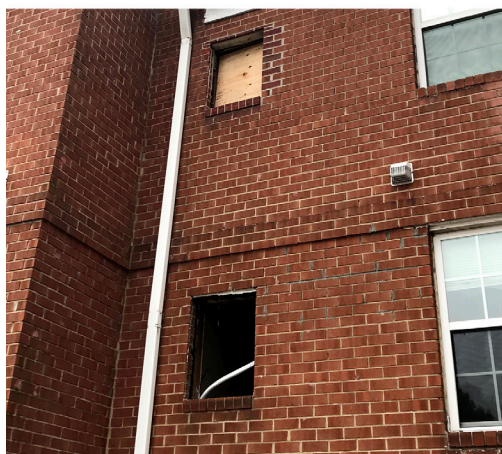
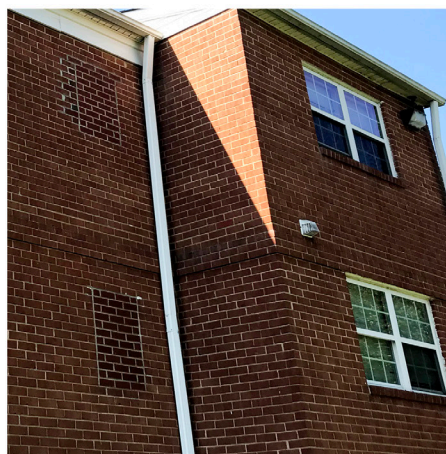
BEFORE AND AFTER: Aging condensing units were replaced with exterior, wall-mounted heat pumps. The abandoned wall penetrations were fully insulated and finished with brick.

- End-of-life gas-fired central boilers with DHW (domestic hot water) coils were removed, and replaced with new high-efficiency air source heat pumps which distribute ducted heating and cooling via EC fan motors. The variable speed split systems achieve up to 19 SEER and 11 HSPF.
